Manhole Inspection Summary

Manhole # S07EE2014MH

Insp Date: **7/19/06 10:18 AM**

Location Address: **6100 GREENSPRING AVE**

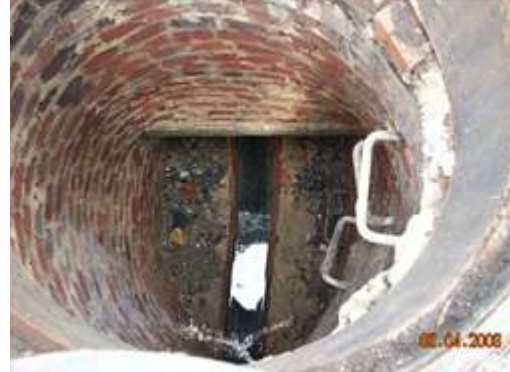
Top View

Corroded steps. Evidence of surcharge - Bench debris.

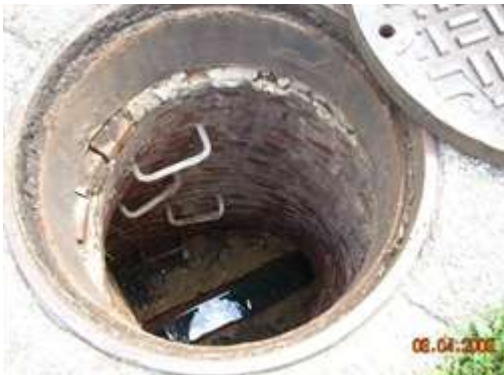
Defect

Frame leaks. Frame offset. Adjustment deterioration and infiltration. Corbel infiltration - other side.

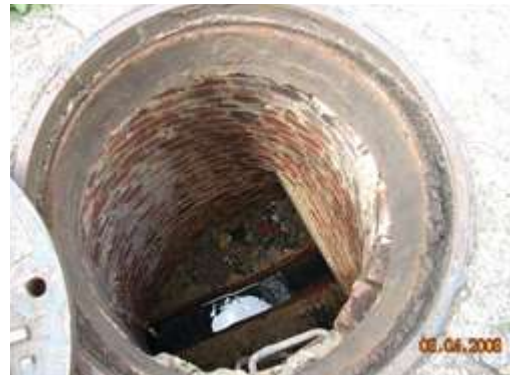
Defect

Frame leaks. Frame offset. Adjustment deterioration and infiltration. Corbel infiltration

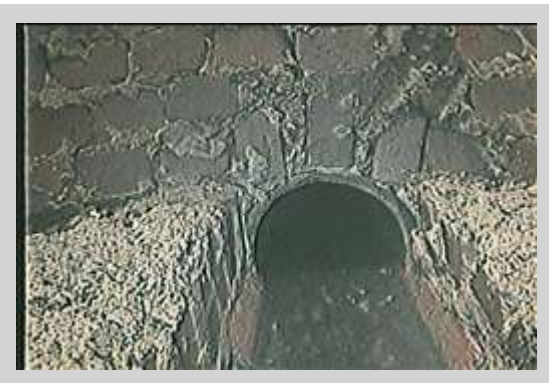
8 in. Circular Gravity Sewer Pipe In @ 3 O'Clock

Barrel deterioration and infiltration.

Deposits: ☐ None ☒ **Mud** ☐ Sludge ☒ **Debris** ☐ Grease

Silt Depth: **1** (in.) Deposits Extent: **Light**

Infiltration: **Evidence** Pipe Seal Cond: **Unknown**

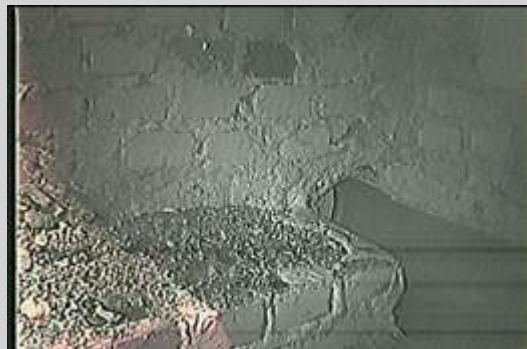
Pipe In @ 6 O'Clock

Pipe Seal Cond: **Cracked**
